TECHNICAL REPORT CERC-85-8

BREAKWATER REHABILITATION STUDY, CRESCENT CITY HARBOR, CALIFORNIA

Coastal Model Investigation

Coastal Engineering Research Center

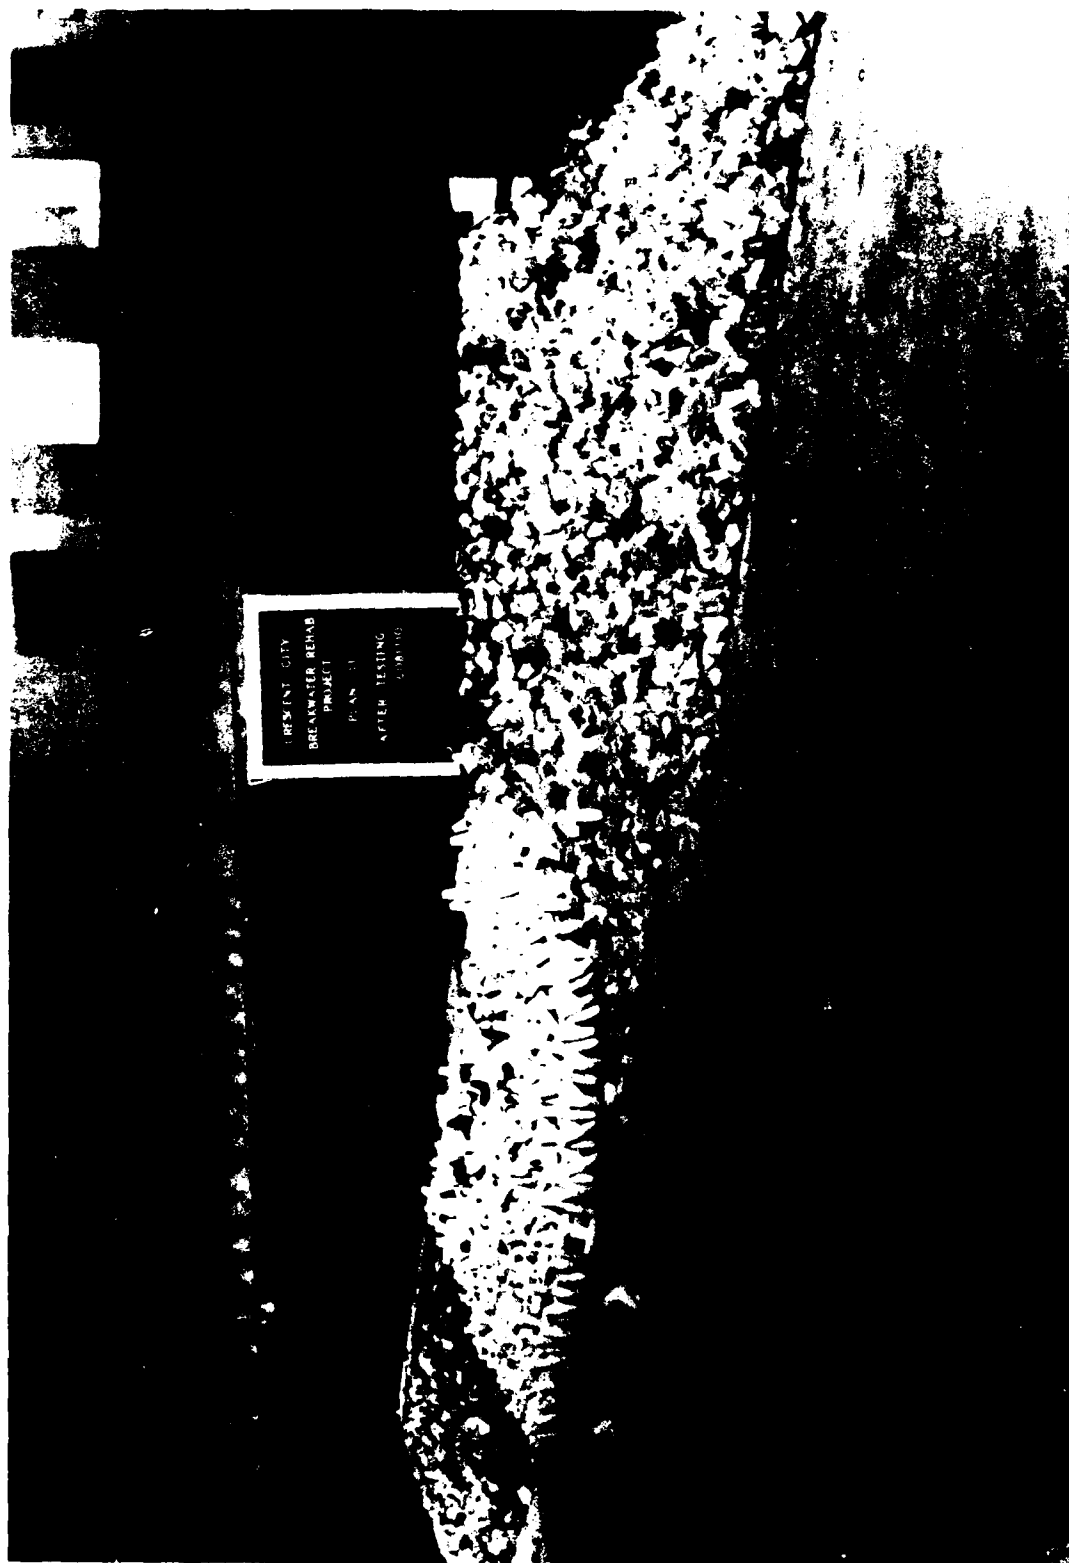
Photo 94. Seaward oblique view of Plan 11 after completion of abbreviated hydrograph

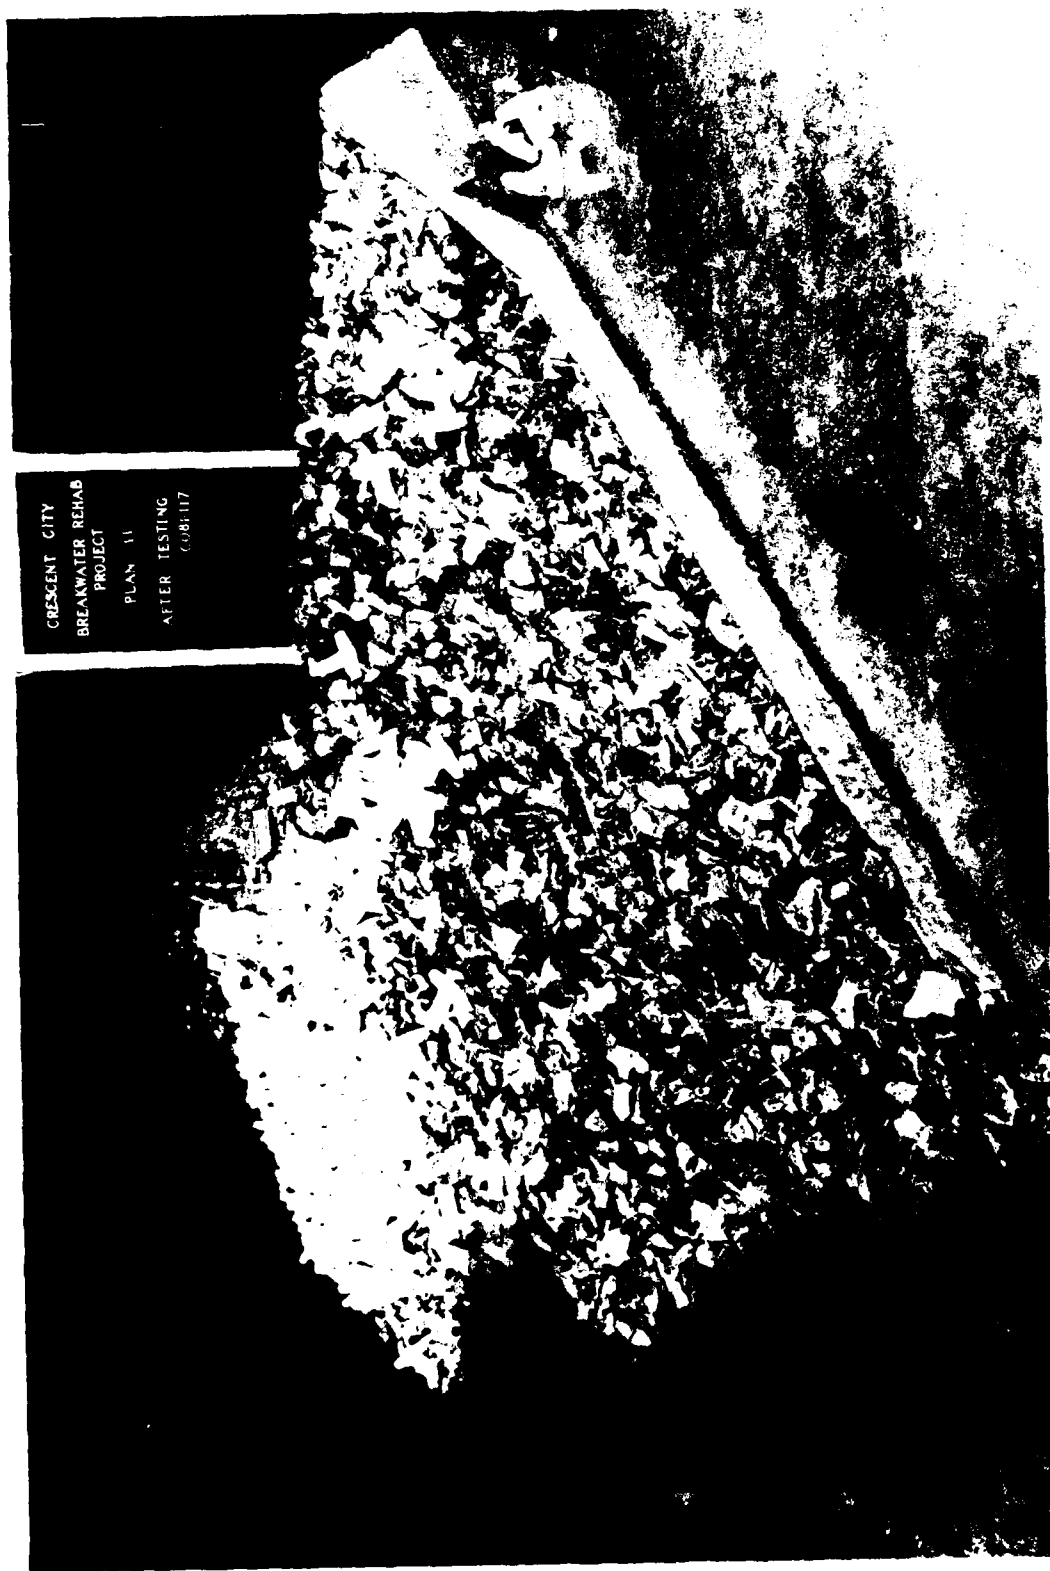
Photo 98. Seaward end view of Plan 11 repeat after completion of abbreviated hydrograph

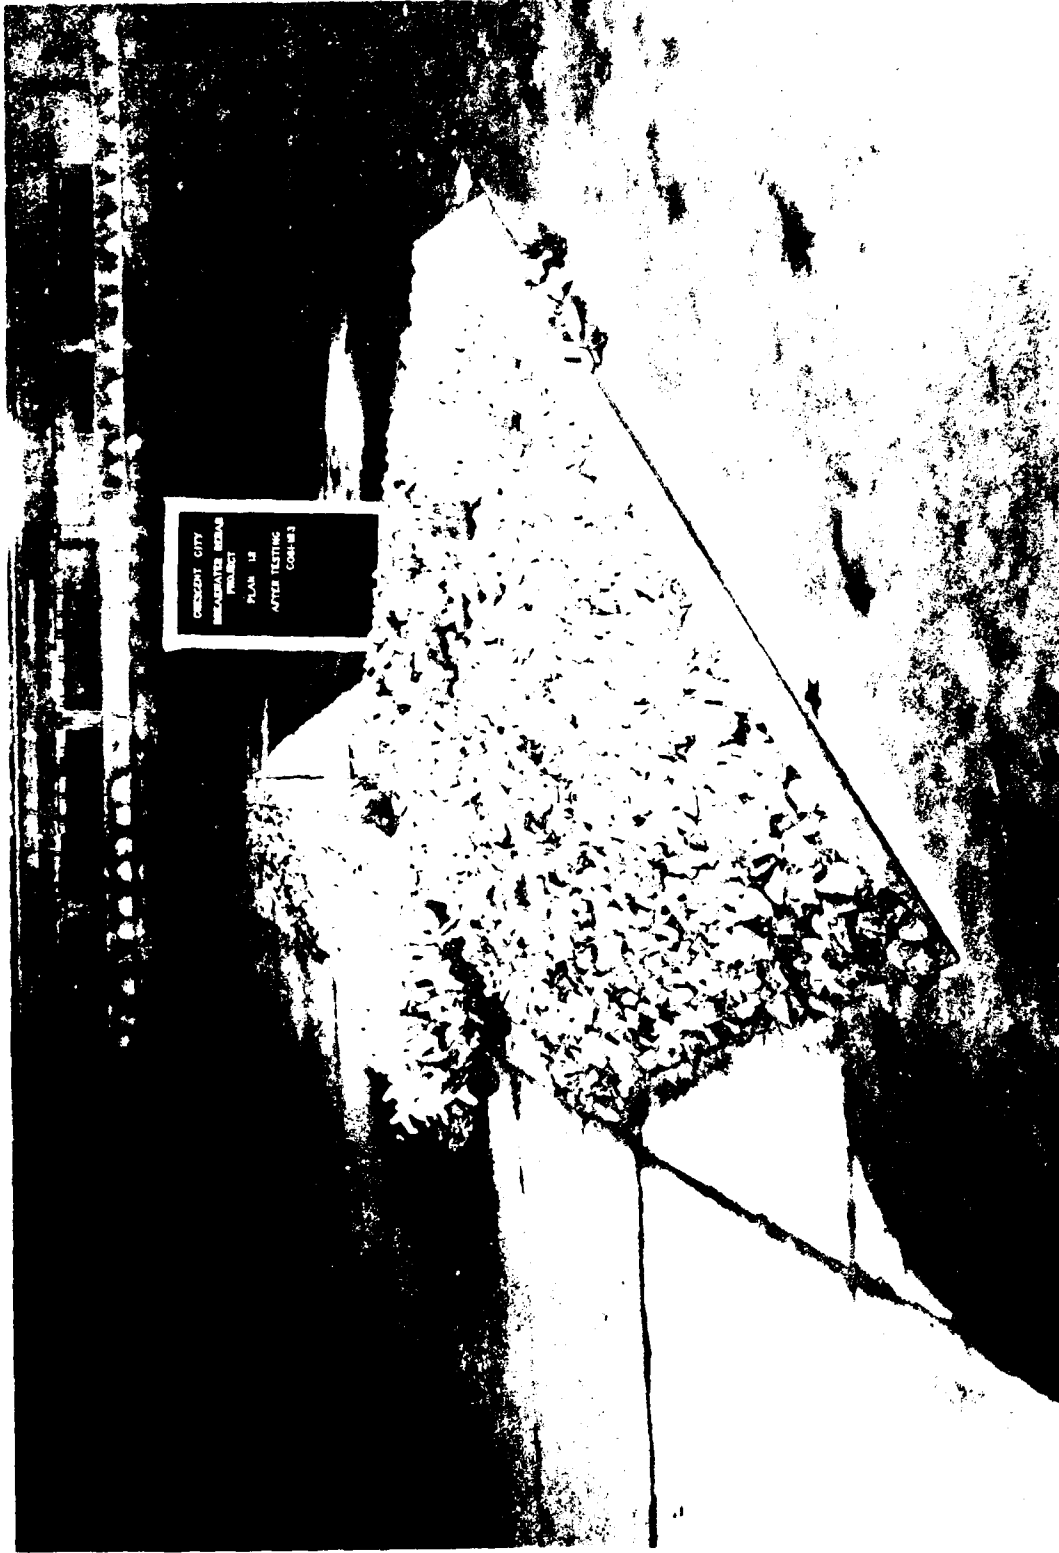
Photo 104. Seaward end view of Plan 12 after completion of abbreviated hydrograph

42. Plan 12 (Plate 16 and Photos 99-101) was constructed with two rows of 58-ton dolosse along the seaward transition of the elbow; the 58-ton units along the toe were randomly placed. It was hoped that the heavier units would stabilize this area without trenching. A total of 46 58-ton and 319 42-ton rehabilitation dolosse were placed. The seaward transition sustained severe damage during testing. Photos 102-104 show the structure after testing.

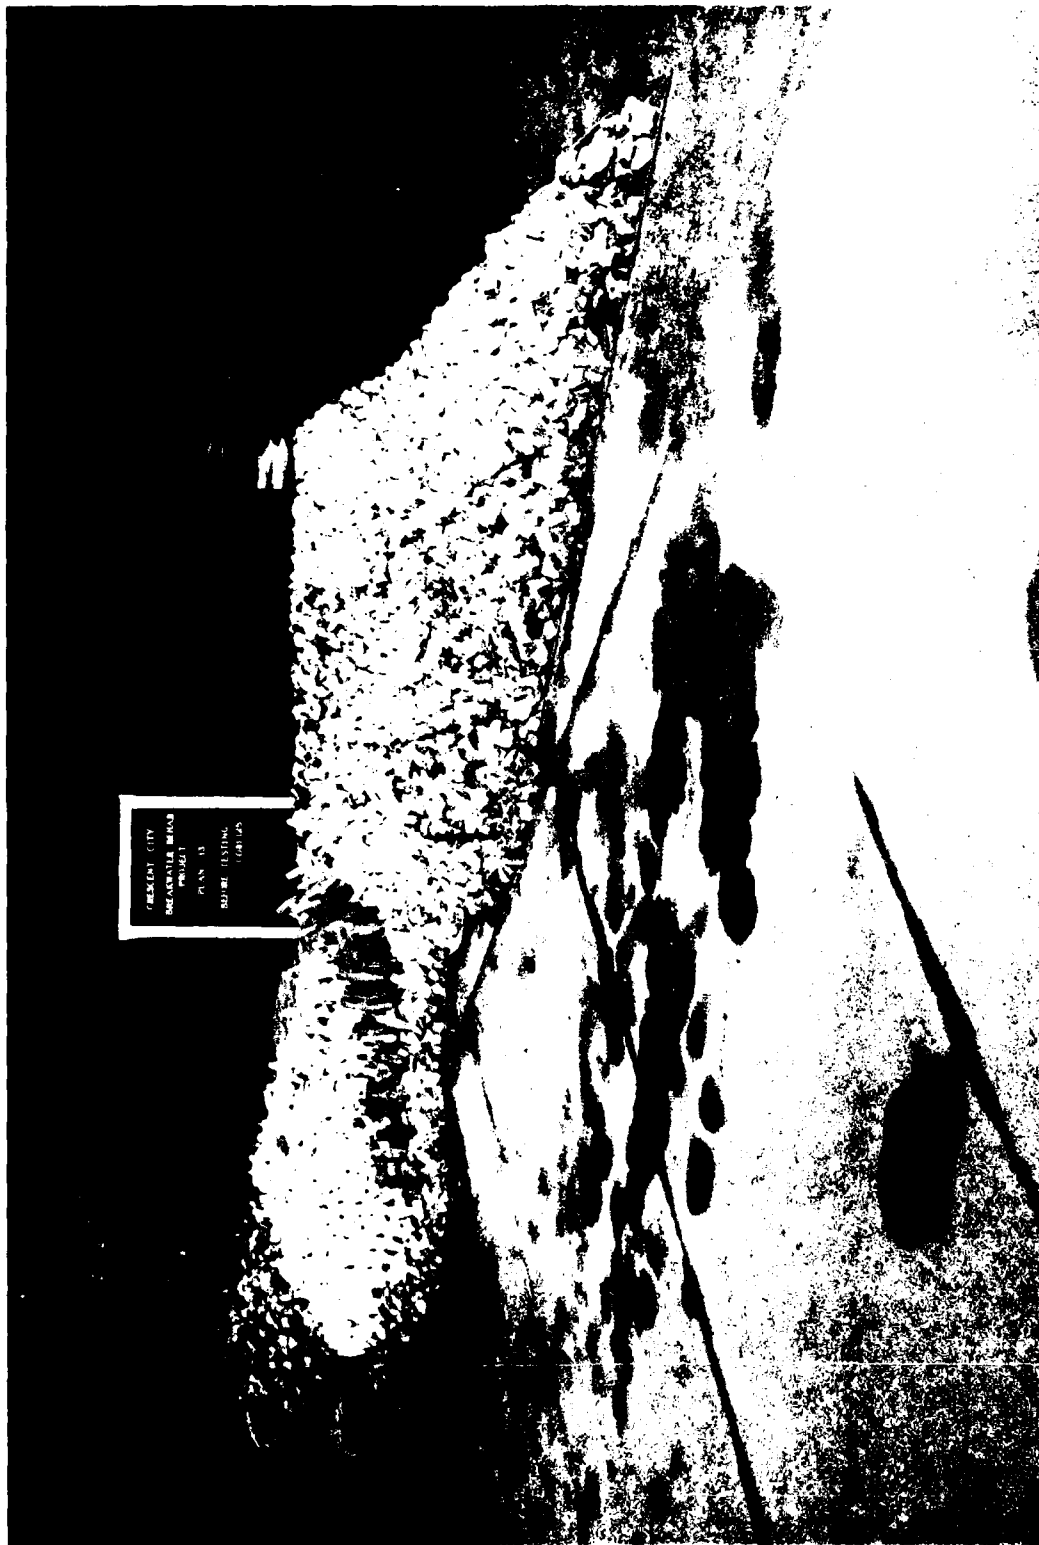
Photo 106. Seaward oblique view of Plan 13 before wave attack

43. Plan 13 (Plate 16 and Photos 105-107) was similar to Plan 12, except some additional 58-ton dolosse were placed. Also, special placement was used for the toe units. A total of 65 58-ton and 313 42-ton rehabilitation units were placed. The seaward transition still sustained damage during testing. Photos 108-110 show the structure after testing.

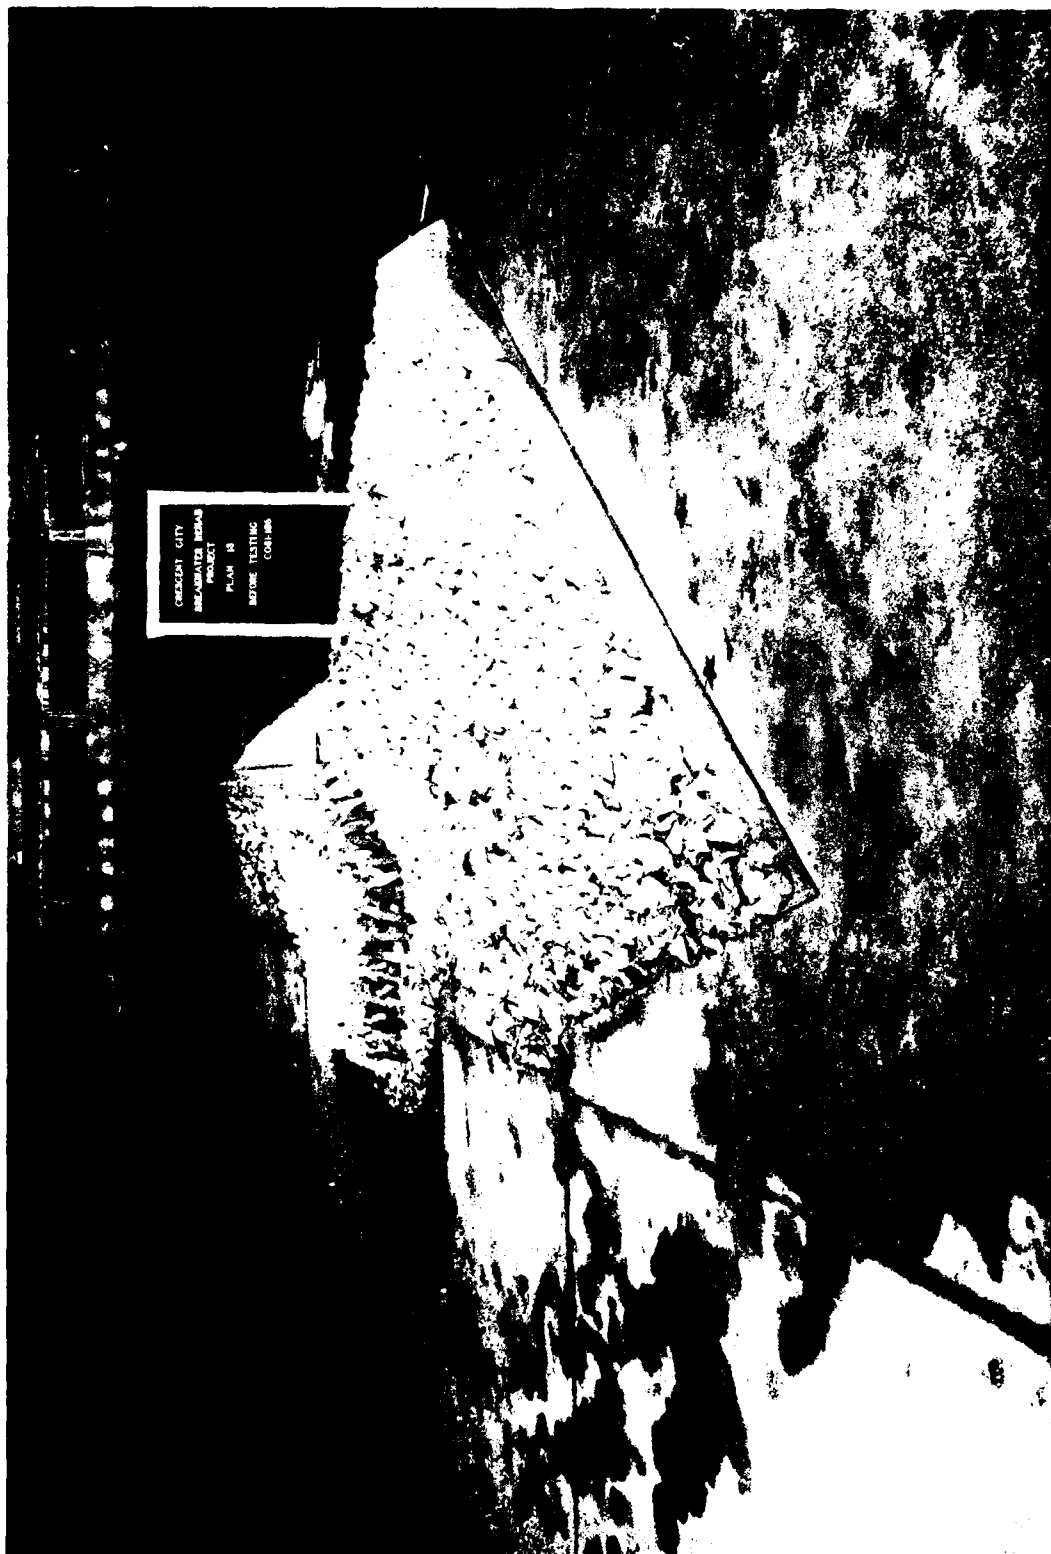
Photo 107. Seaward end view of Plan 13 before wave attack

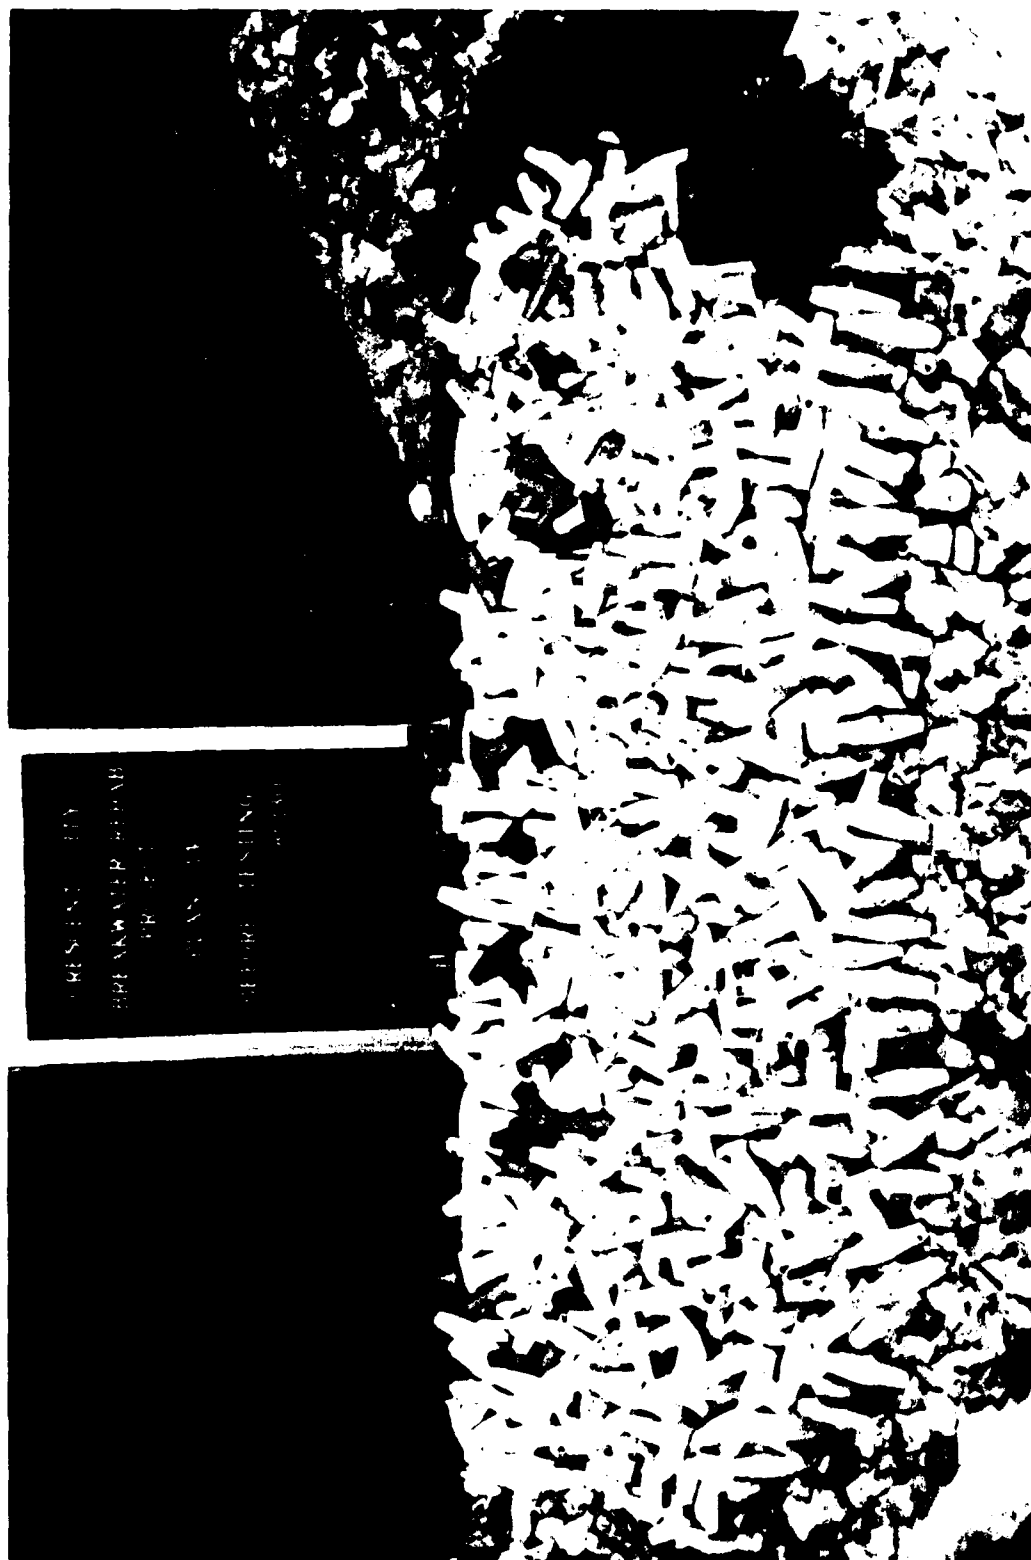
Photo 111. Sea-side view of Plan 14 before wave attack

44. Plan 14 (Plate 16 and Photos 111-113) was similar to Plan 13, except a trench was excavated along part of the seaward transition. A total of 61 58-ton and 312 42-ton rehabilitation units were placed. Again the seaward transition sustained damage during testing. Photos 114-116 show the structure after testing. At this time it was decided that the larger units exhibited more surface area for the waves to work on and were not a feasible alternative unless higher density concrete was used, which in effect, would increase the weight without increasing the surface area. Since high-density model units were not available to show this effect and the time limitation prevented making additional model units, future efforts concentrated on finding a stable section using the 42-ton dolosse.

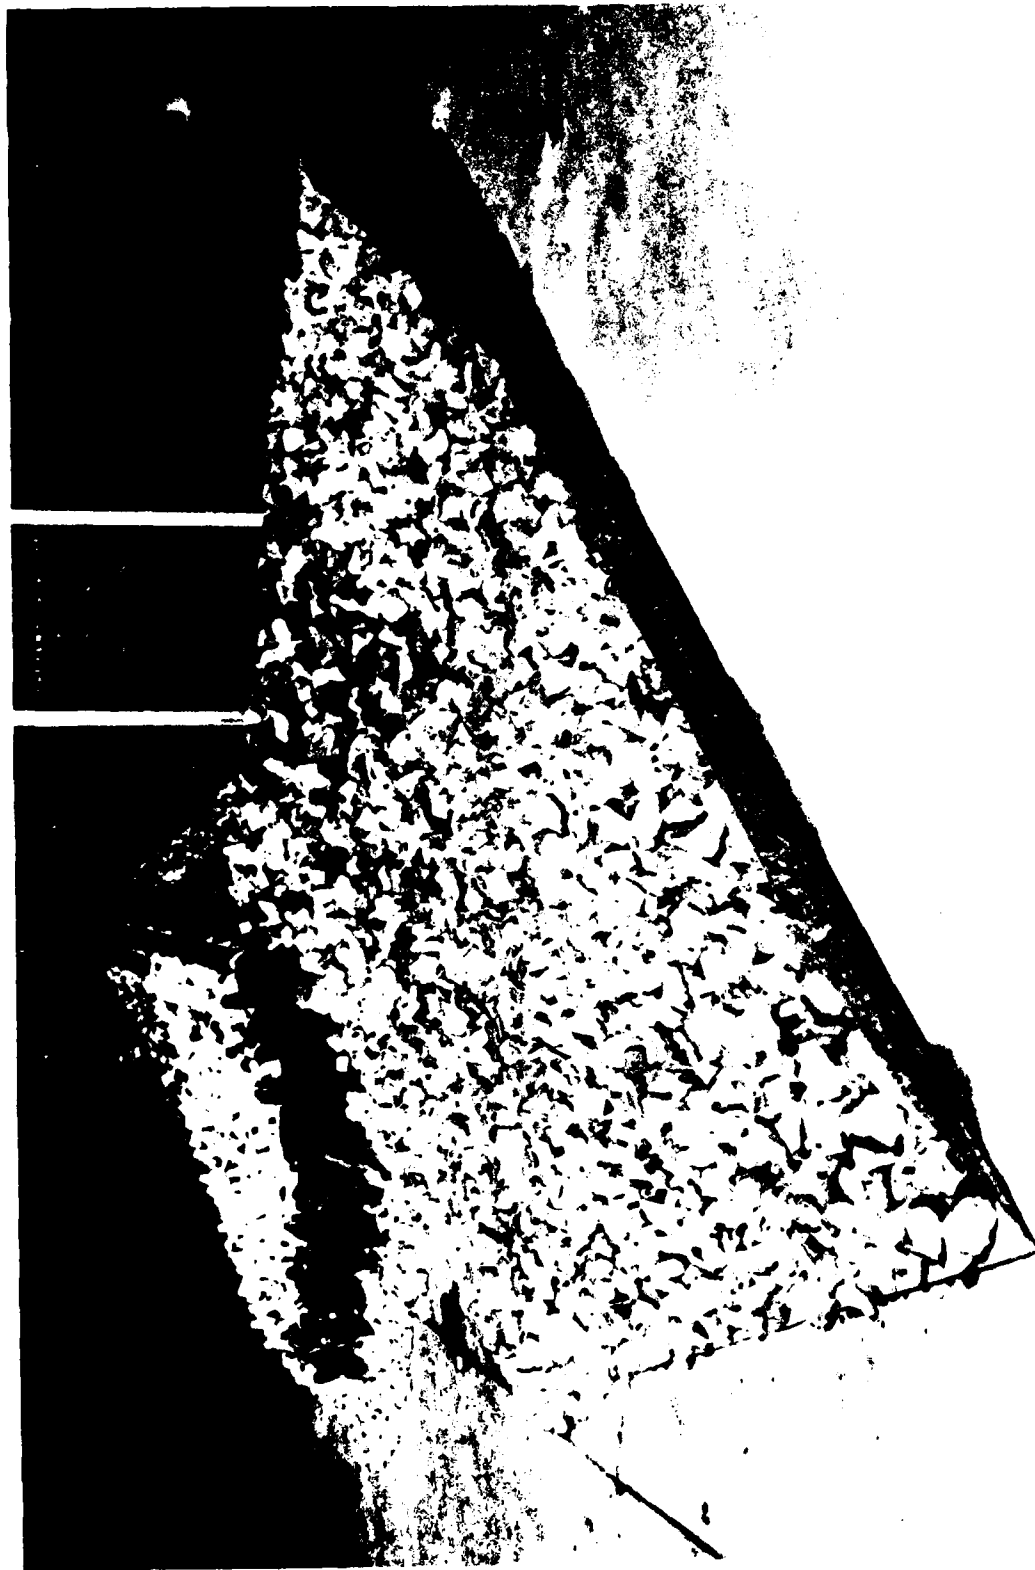
Photo 113. Seaward end view of Plan 14 before wave attack

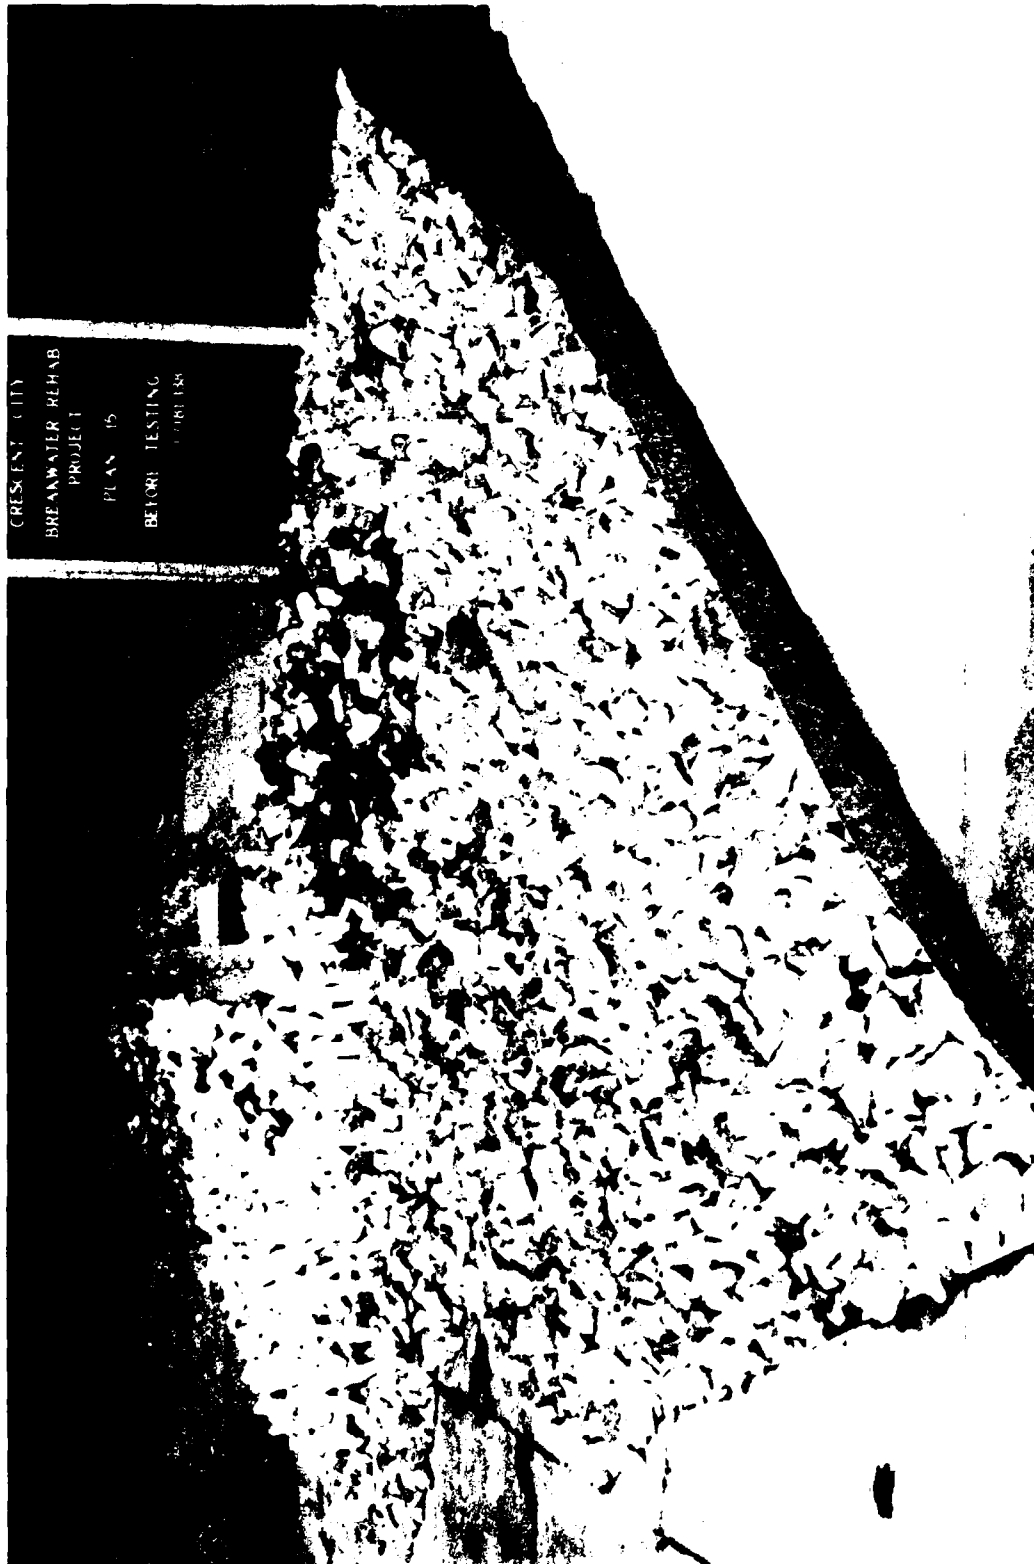
Photo 119. Seaward end view of Plan 15 before wave attack

45. Plan 15 (Plate 17 and Photos 117-119) was constructed with a trench approximately one dolos wide and about 5 ft (one-stone-diameter) deep. After the units were placed in the trench, the voids between units in the trench were backfilled with material left over from the excavation. Special placement was used for the toe units. The total number of 42-ton rehabilitation units was 373. Again damage exceeded acceptable limits. Although much of the backfill material was scoured out during testing, placement of the backfill material did improve the stability of the seaward transition. Photos 120-122 show the structure after testing.

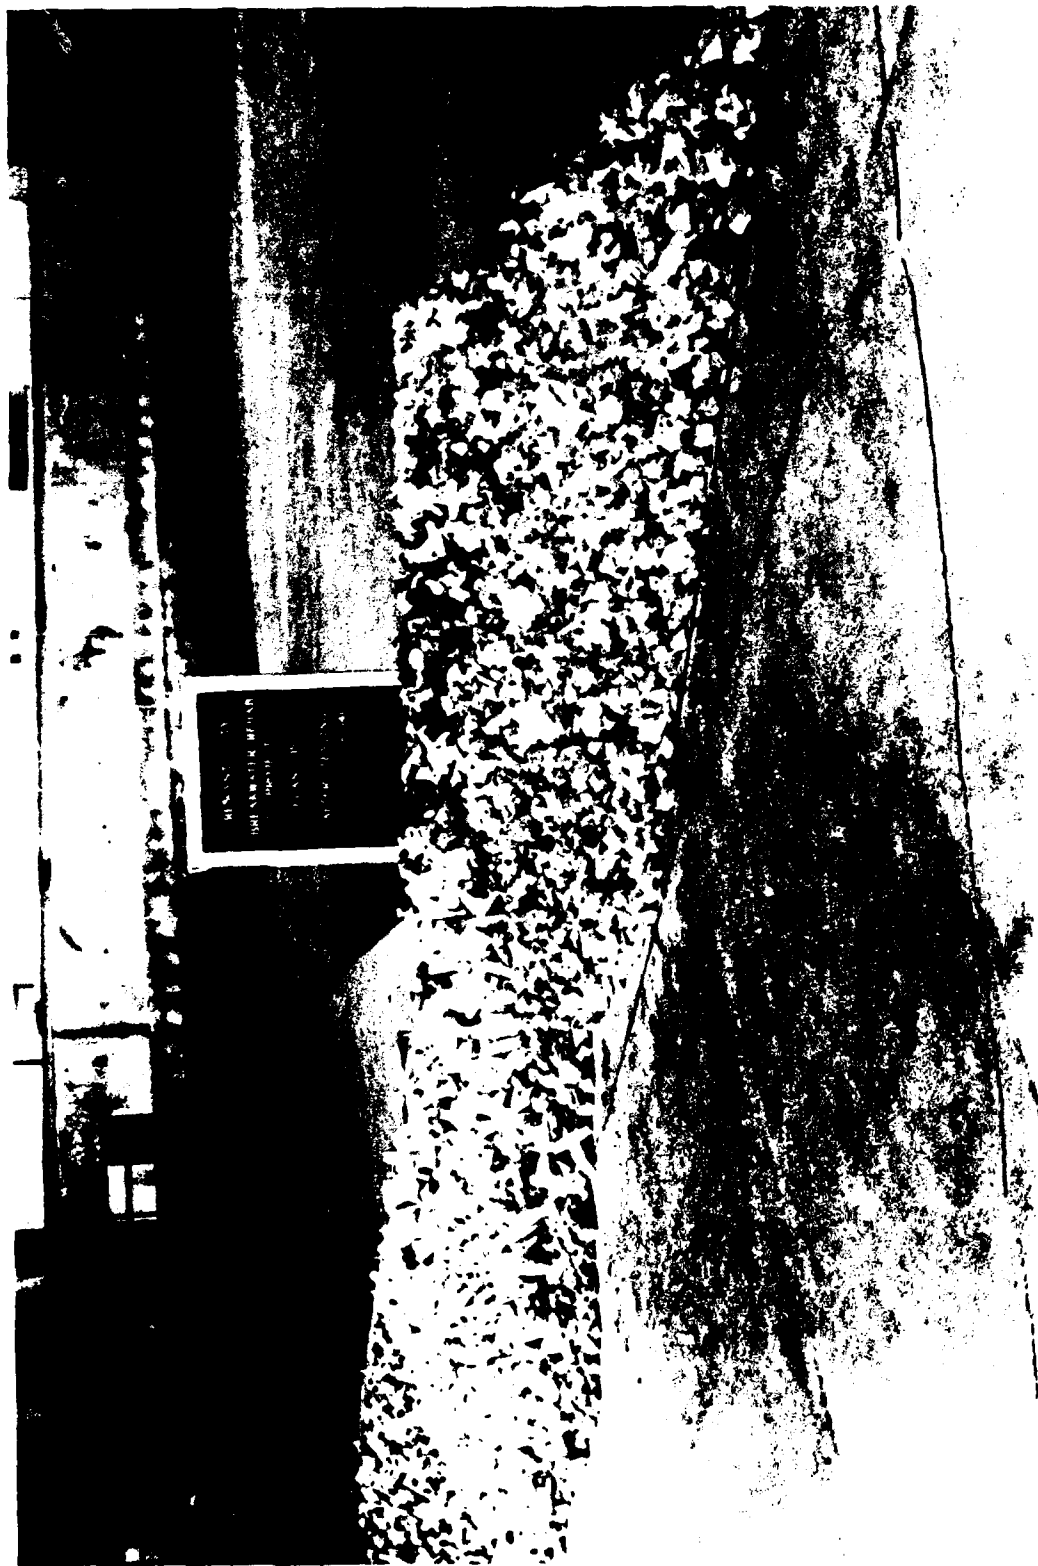
Photo 121. Seaward oblique view of Plan 15 after completion of abbreviated hydrograph

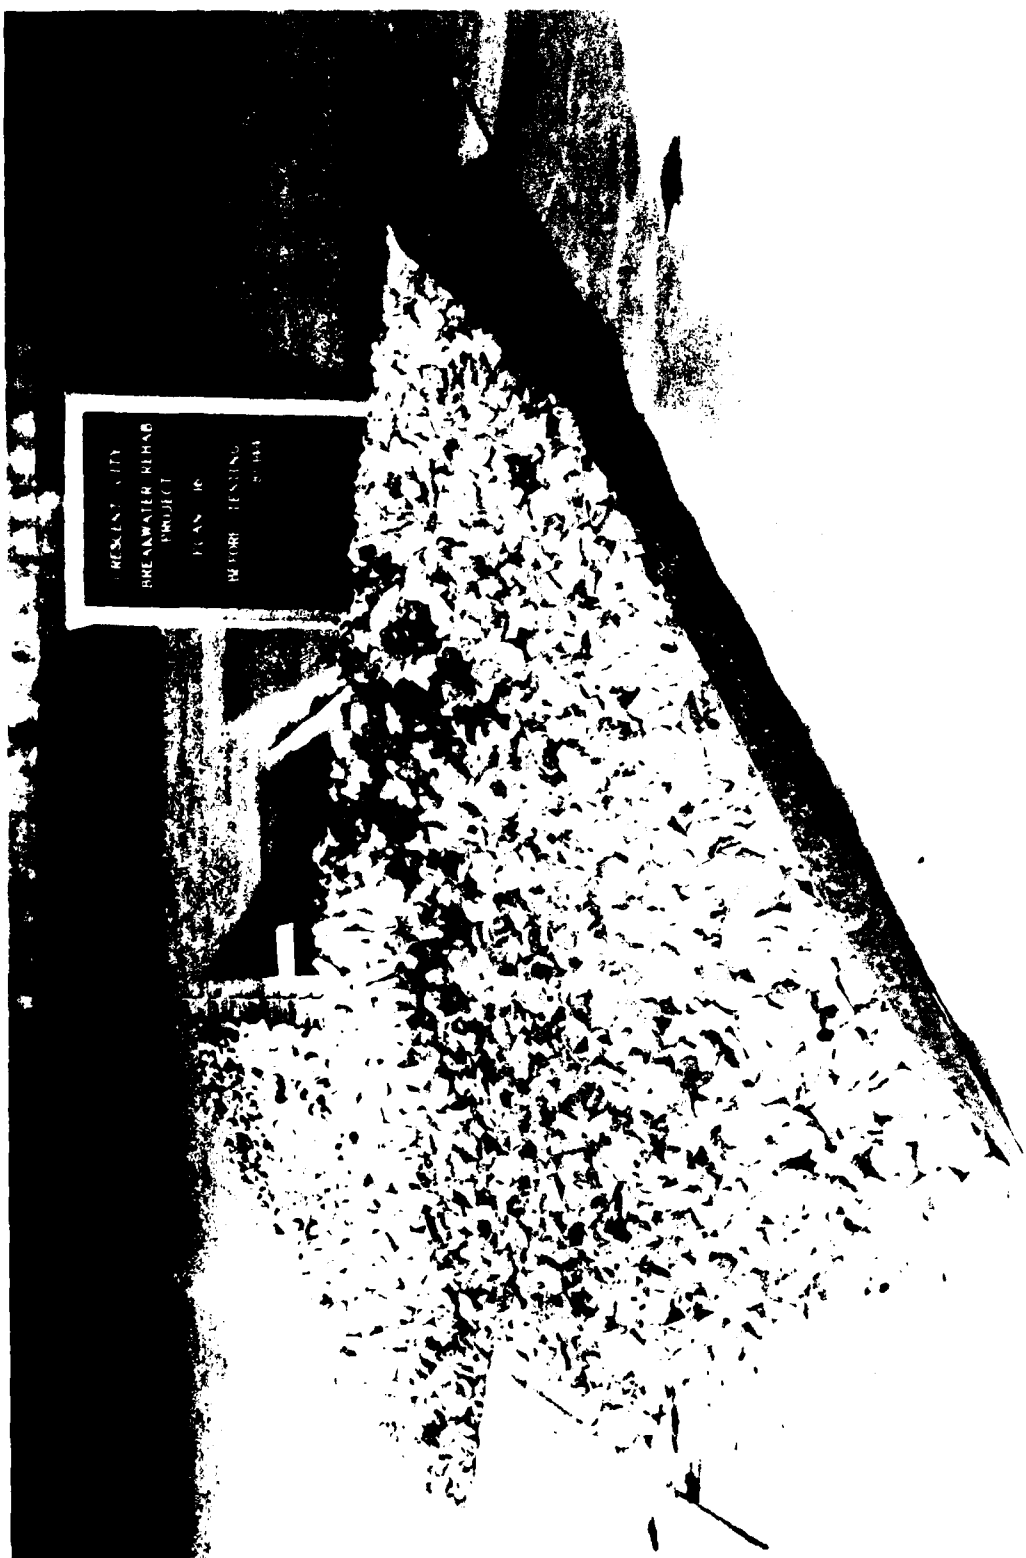
Photo 125. Seaward end view of Plan 16 before wave attack

except the area of coverage was increased. The waves tended to break on the structure and then rush out the dogleg, and it was hoped additional units in this area would dissipate enough of the wave energy to protect the toe units in the seaward transition area of the elbow. A total of 406 42-ton rehabilitation dolosse were used. Damage of the seaward transition was still unacceptable. Photos 126-128 show the structure after testing.

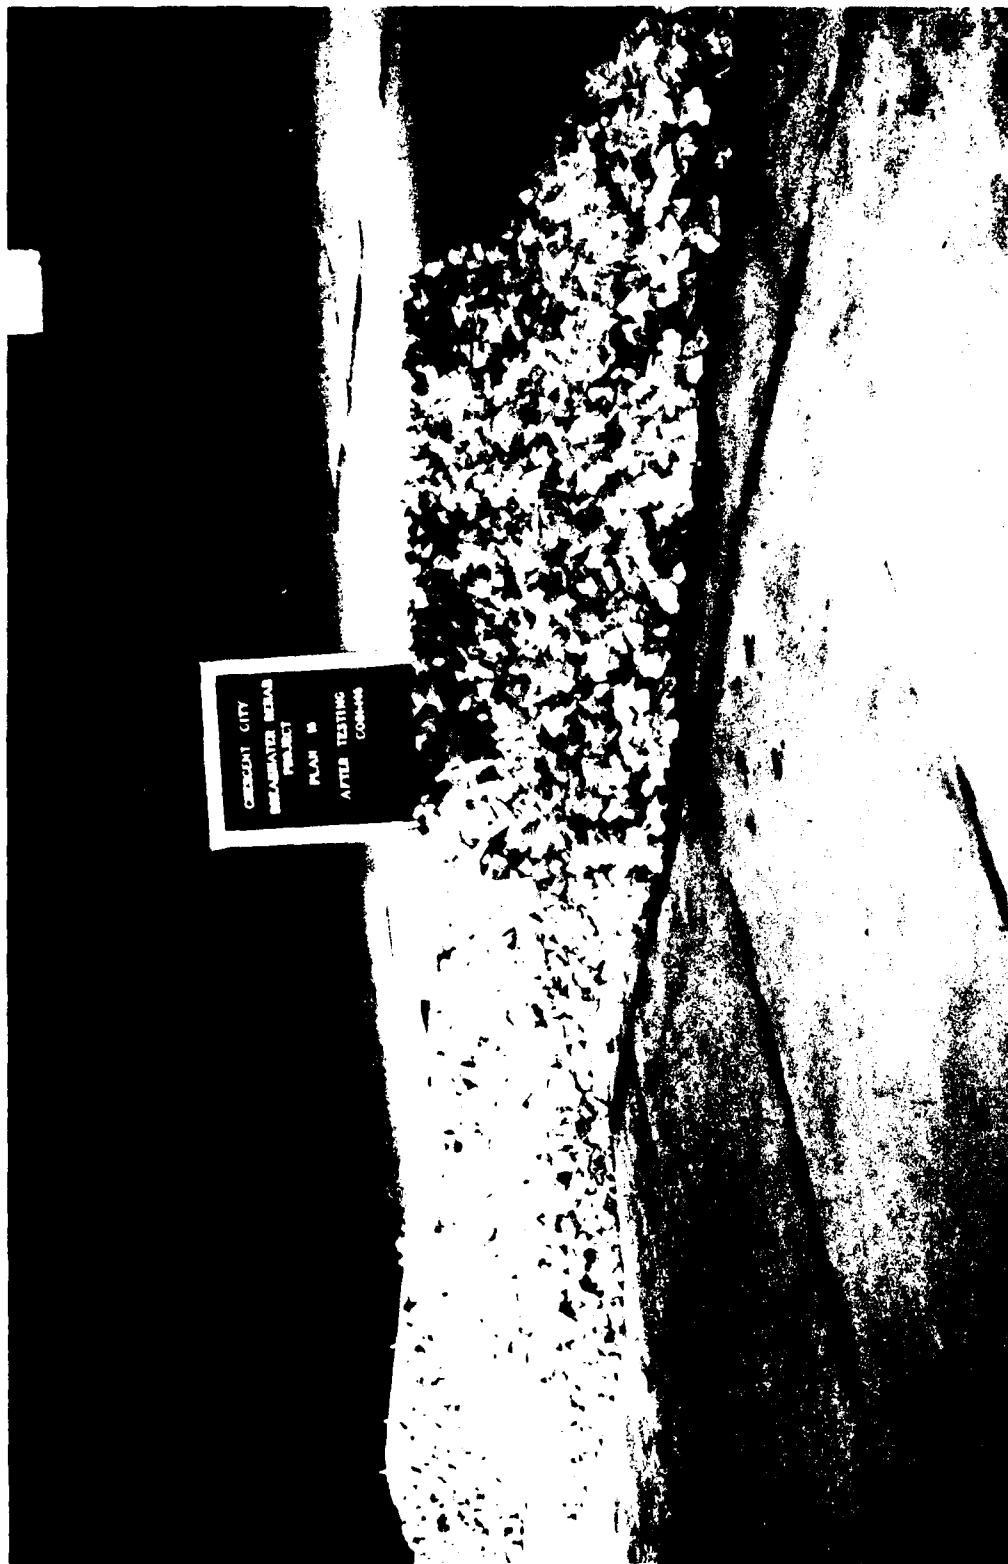
Photo 127. Seaward oblique view of Plan 16 after completion of abbreviated hydrograph

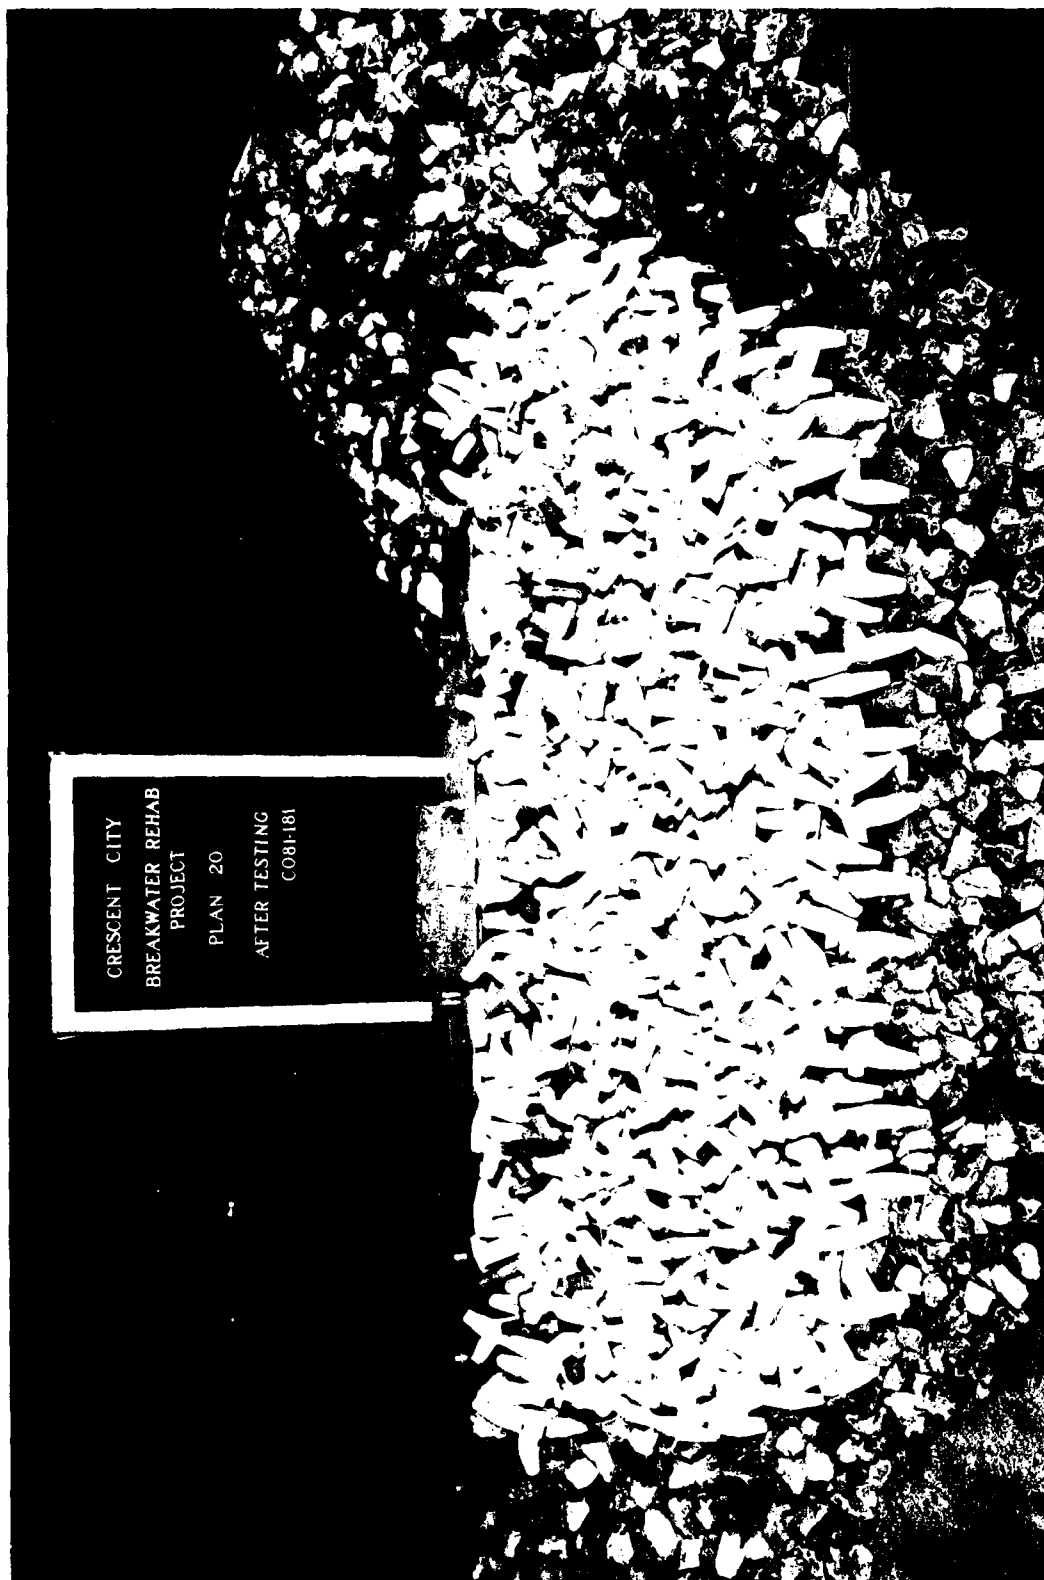
Photo 157. Sea-side view of Plan 20 after completion of abbreviated hydrograph

50. Plan 20 (Plate 22 and Photos 154-156) had about the same area of coverage as Plan 18; however, 74 rehabilitation dolosse were removed and replaced with 82 37-ton tetrapods (37-ton tetrapods were used since this was the model size tetrapod available nearest to the 42-ton dolos size). The tetrapods were placed in one layer. It was thought that the tetrapods might be a more appropriate shape for interfacing the existing stone. A total of 334 42-ton dolosse were used. The tetrapods suffered extensive damage. There was minimum movement of the dolosse during the abbreviated hydrograph, but since they had lost the protection afforded by the tetrapods it is likely damage would have progressed to this area for a longer duration storm. Photos 157-159 show the structure after testing.

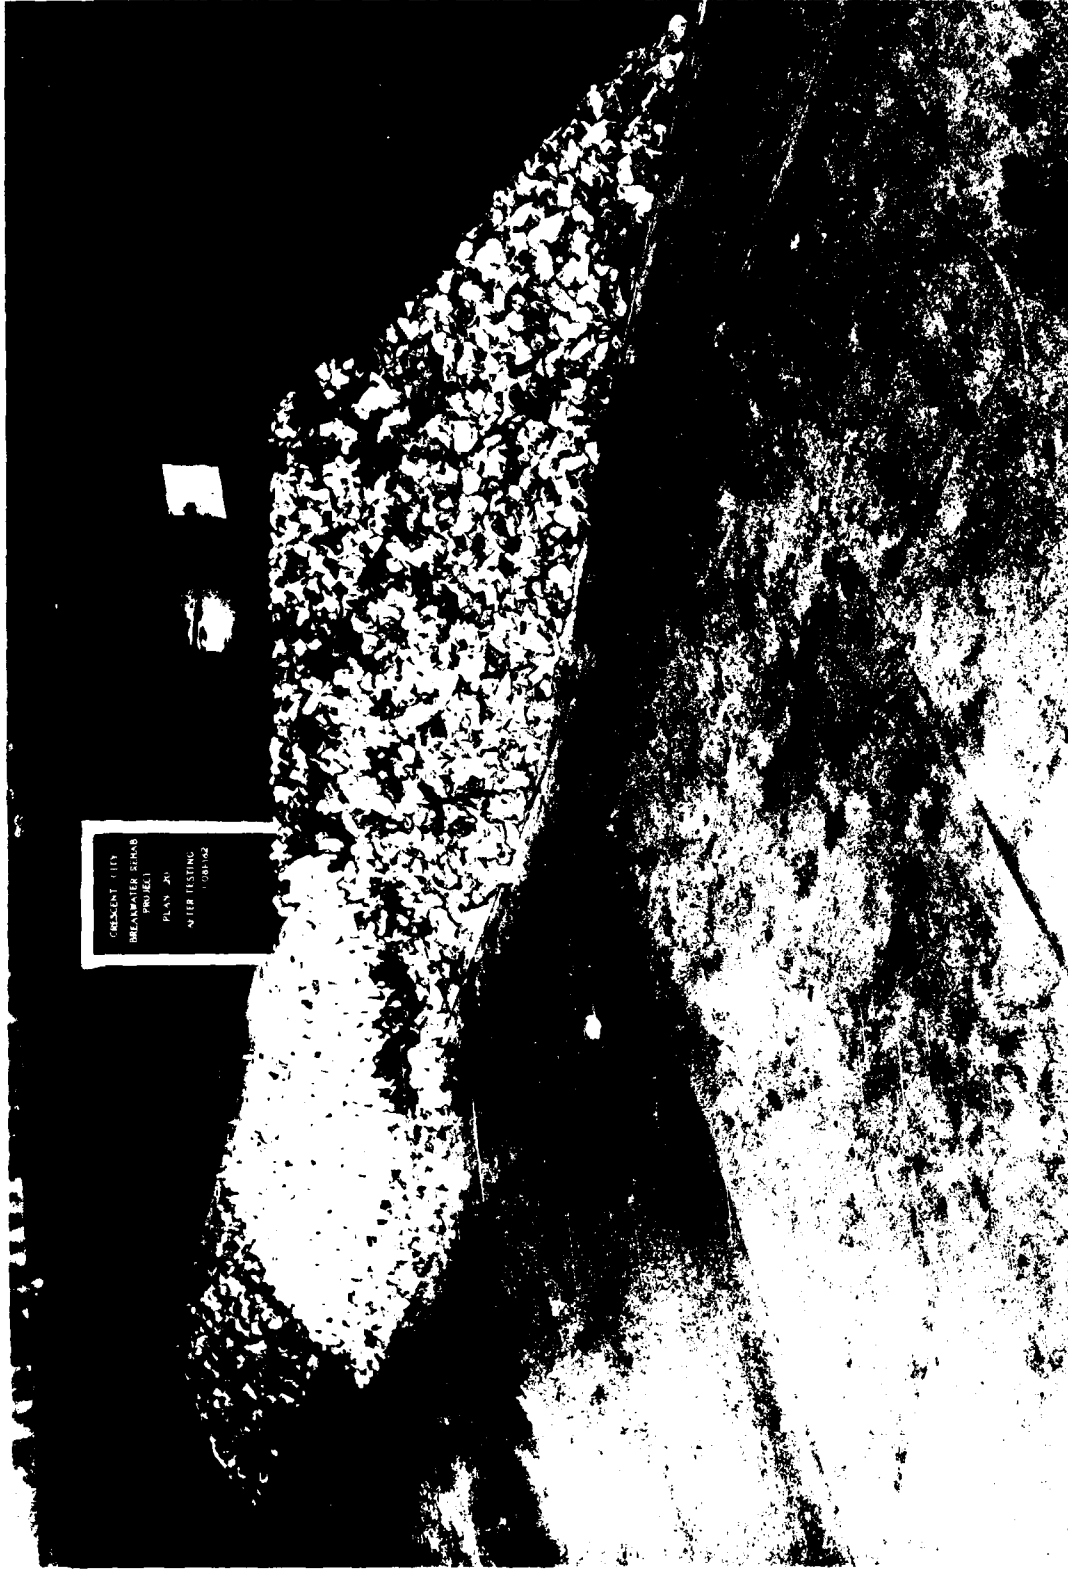
Photo 158. Seaward oblique view of Plan 20 after completion of abbreviated hydrograph
